STATEWIDE HOME INSPECTIONS

PROPERTY INSPECTION REPORT FORM

Your information	
Name of Client	Date of Inspection
Your information	
Address of Inspection Property	
Ruben Max Vega	24262
Name of Inspector	TREC License #
Name of Sponser (if applicable)	TREC License #

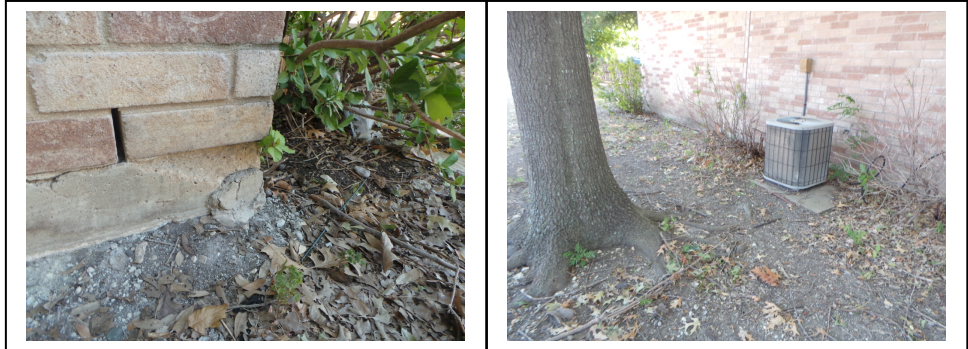
A. Foundations

- The foundation has shifted in some areas evident mainly by patched cracks to the interior and exterior walls. There are indications of past foundation repair. We recommend you refer to the structural engineer's report if available for further information of repairs, warranty and proper maintenance of the foundation. If there are no records that confirm that the foundation was repaired by a qualified specialist, we recommend a foundation specialist be consulted for further evaluation. The foundation should of course be monitored and proper maintenance should be maintained to minimize foundation movement. Pitted areas/spalling were observed on the exterior foundation beam, at more than one location. Trees that are too close to buildings can potentially cause structural damage.

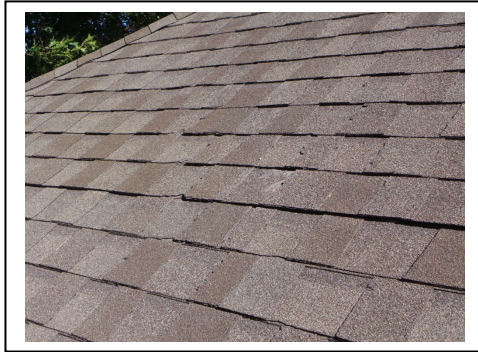
C. Roof Covering Materials

- The shingles on the roof are showing indications of light granule loss and light hail damage, some damaged shingles were noted and some nails are not properly sealed. The roof is full of debris; recommend it be cleaned. Recommend a roofer be consulted for further evaluation/repairs and check for other repairs that may be needed at that time.

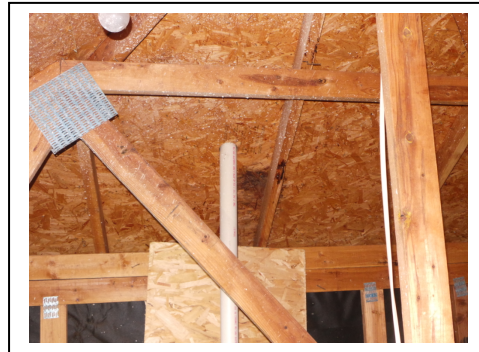
D. Roof Structures and Attics

- Water staining was noted to the decking in the attic. I partially entered the attic for inspection.

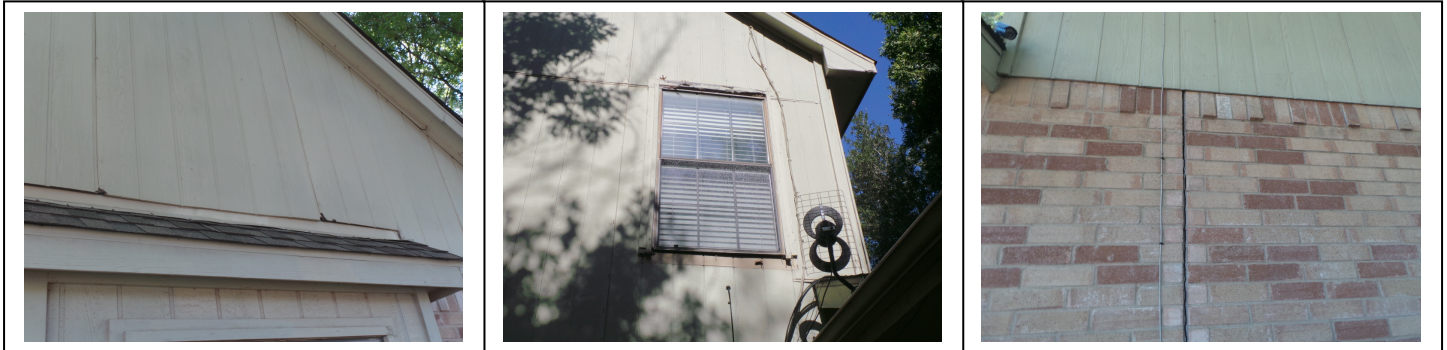
E. Walls (Interior and Exterior)

- There is some deterioration or damaged to the exterior siding/trims, soffits/fascia. There is some damage to at least one interior wall in the master bedroom. I am unable to determine the condition of the underlying materials.
- Caulking/grout is needed in some areas outside mainly around the windows and expansion joint. I am unable to determine the condition of the underlying materials.

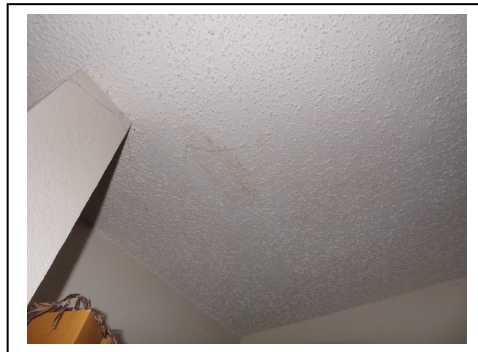
F. Ceilings and Floors

- Water staining was noted to the ceiling in the master closet.
- There are some cracks to the floor in the driveway. The floors are uneven in some areas.

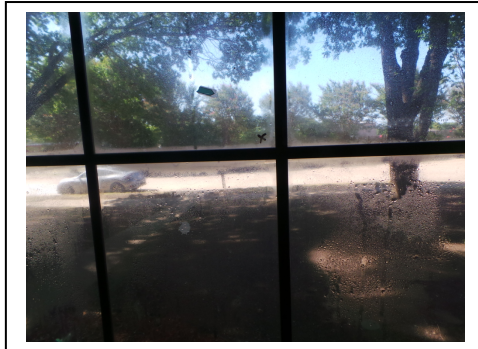
H. Windows

- There are some window panes that have lost their thermal seals. (Sample marked with a black X). Some windows with lost seals may not have been evident during the inspection because this could appear and disappear as temperature and humidity changes. Some of the window screens are damaged.

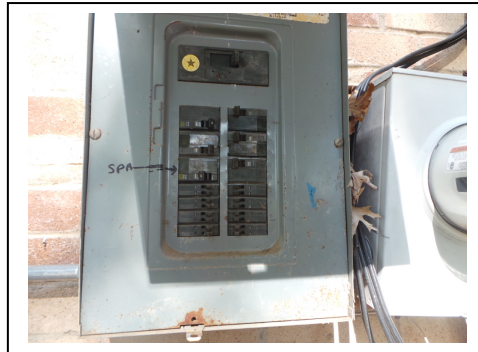
<input checked="" type="checkbox"/>	<input type="checkbox"/>	<input type="checkbox"/>	<input checked="" type="checkbox"/>	A. Service Entrance and Panels <i>Most components of the electrical systems are not readily accessible, unable to fully inspect. Unable to inspect underground services and the depth of ground rods.</i> Comments: <ul style="list-style-type: none"> The breakers in the main electrical panel are not properly/completely labeled. There is no AFCI (Arc Fault Circuit Interrupter) for all recommended electrical outlets in the bedrooms. Rust and corrosion was noted to the main electrical panel.
-------------------------------------	--------------------------	--------------------------	-------------------------------------	--

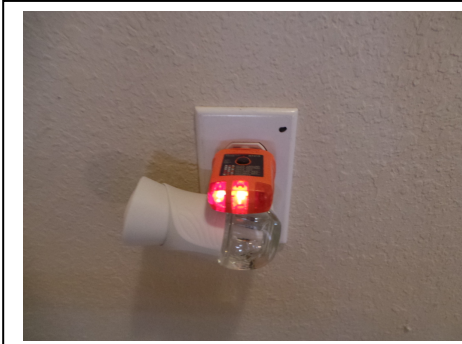
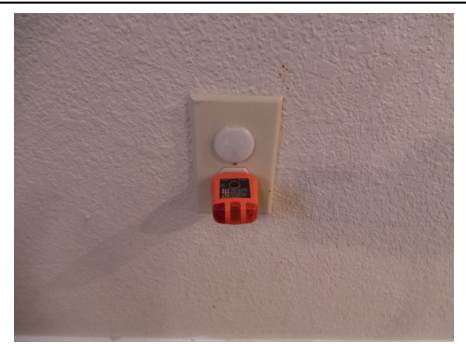
B. Branch Circuits, Connected Devices and Fixtures

- There is at least one electrical outlet that registers hot/neutral reversed in the upstairs hall area. Marked with a black dot.
- The GFIC (Ground Fault Circuit Interrupter) electrical outlet in the kitchen registers no power.

- There is at least one electrical outlet that registers no power in the living area and kitchen area. Marked with a black Dot.
- The entry light does not respond when tested. If the bulb is not blown, the circuit should be investigated.

- There is bare-bulb type of light fixtures in the closets.
- The doorbell did not respond when tested.
- There is some damage/missing electrical knobs in the dining area and upstairs rear right bedroom.

- There are some visible unprotected wiring splices and wires in the cabinet under the kitchen sink.
- I was unable to determine the function of some of the light switches. Marked with a black Dot.

- There is no GFCI (Ground Fault Circuit Interrupter) for all recommended electrical outlets in the kitchen and garage.
- Smoke detectors were not noted in all the bedrooms.

- Some of the electrical outlet/switch covers are missing/damaged.
- Recommend a license electrician be consulted for further evaluation/repairs and check the entire system for proper and safe operation and for other repairs that may be needed at that time.

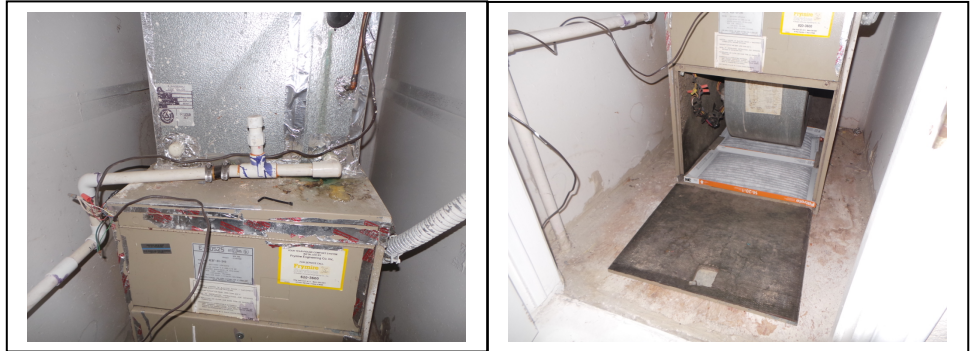
A. Heating Equipment

- There is no secondary a/c drain line at the heating unit. The cover plate is loose at the heating unit. Water staining was noted to the heating unit. The heating unit is not operating properly, evident mainly by temperature of 90 degrees. Recommend consulting an a/c specialist for further evaluation/repairs and check the entire system for other repairs that may be needed at that time.

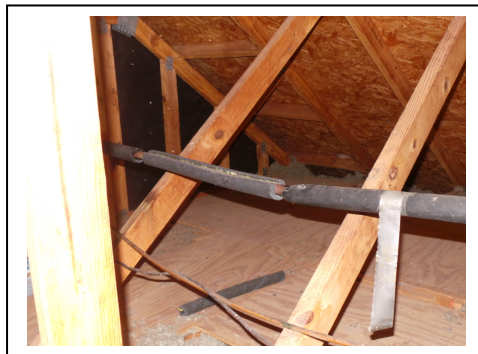
B. Cooling Equipment

- The insulation on the a/c suction line is damaged/missing in the attic and outside. The cooling fins are damaged/flattened on the coils of the outside a/c condensing unit. The thermostat is loose.

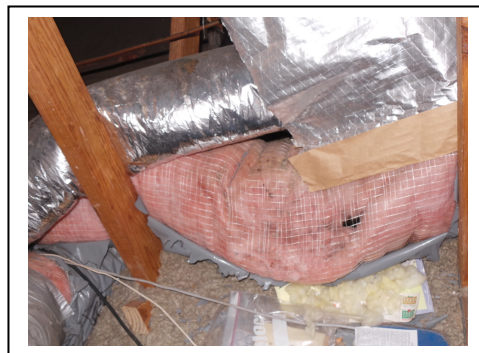
C. Duct system, Chases, and Vents

- Damage was noted to the grey plastic around the ductwork. Recommend consulting an a/c specialist for further evaluation/repairs and check the entire system for other repairs that may be needed at that time.

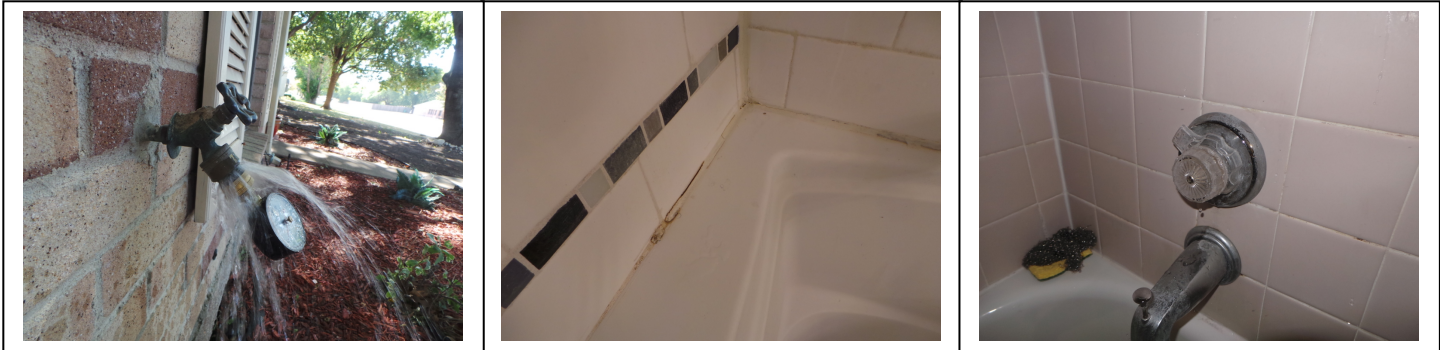
A. Plumbing Supply, Distribution Systems and Fixtures

- There is a water leak at the front exterior anti-siphon device when the water is running.
- The bathrooms enclosures need caulk/grout repair to help prevent water penetration. I am unable to determine the condition of the underlying materials.
- The faucet handle is not properly operating to the upstairs bathtub.
- I was unable to locate the water meter. The water meter should be checked for movement indicating possible leaks.

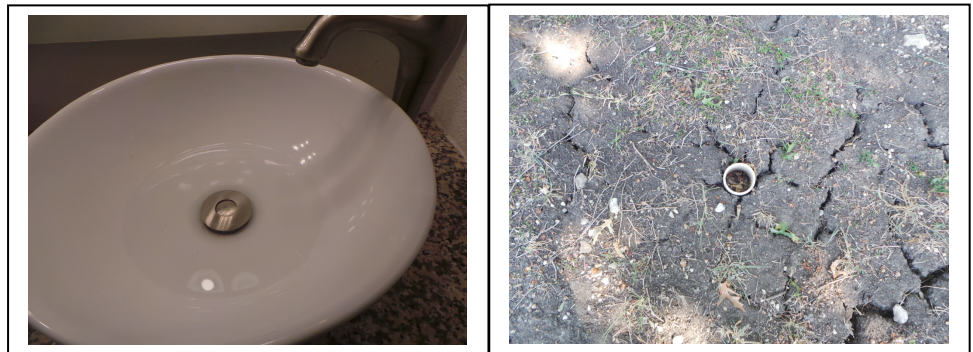
B. Drains, Wastes, and Vents

- The right master sink and master bathtub drain very slowly. This suggests that an obstruction may exist.
- The cover for at least one cleanout is missing.
- The drain stop for the bathtubs and upstairs bathroom sink are missing.
- The master and hall bath commode are loose, and need to be properly attached to the floor.

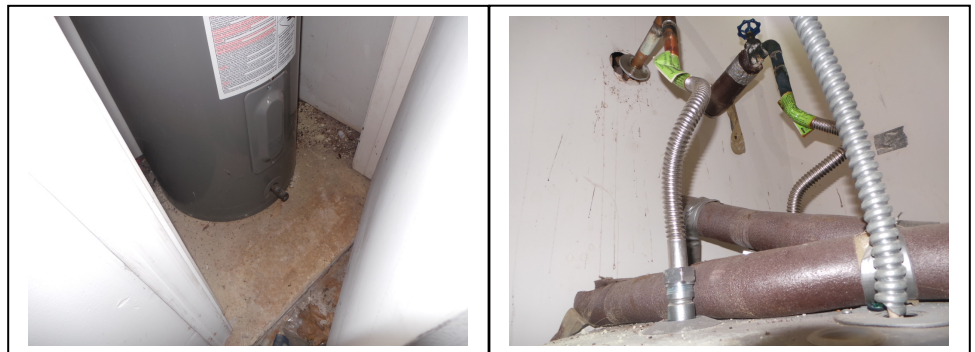
C. Water Heating Equipment

- There is no drain pan noted below the water heater unit. The water heater supply lines are not properly/completely insulated. The water heater is not 18 inches above the lowest garage floor elevation.
